# EXAMINATION OF DELTAIC PROCESSES OF MISSISSIPPI RIVER OUTLETS—CAERNARVON DELTA AND BOHEMIA SPILLWAY IN SOUTHEASTERN LOUISIANA

**John A. Lopez, Theryn K. Henkel, Andreas M. Moshogianis, Andy D. Baker,  
Ezra C. Boyd, Eva R. Hillmann, Paul F. Connor, and David B. Baker**

*Lake Pontchartrain Basin Foundation, 2045 Lakeshore Dr., Ste. 339, New Orleans, Louisiana 70122, U.S.A.*

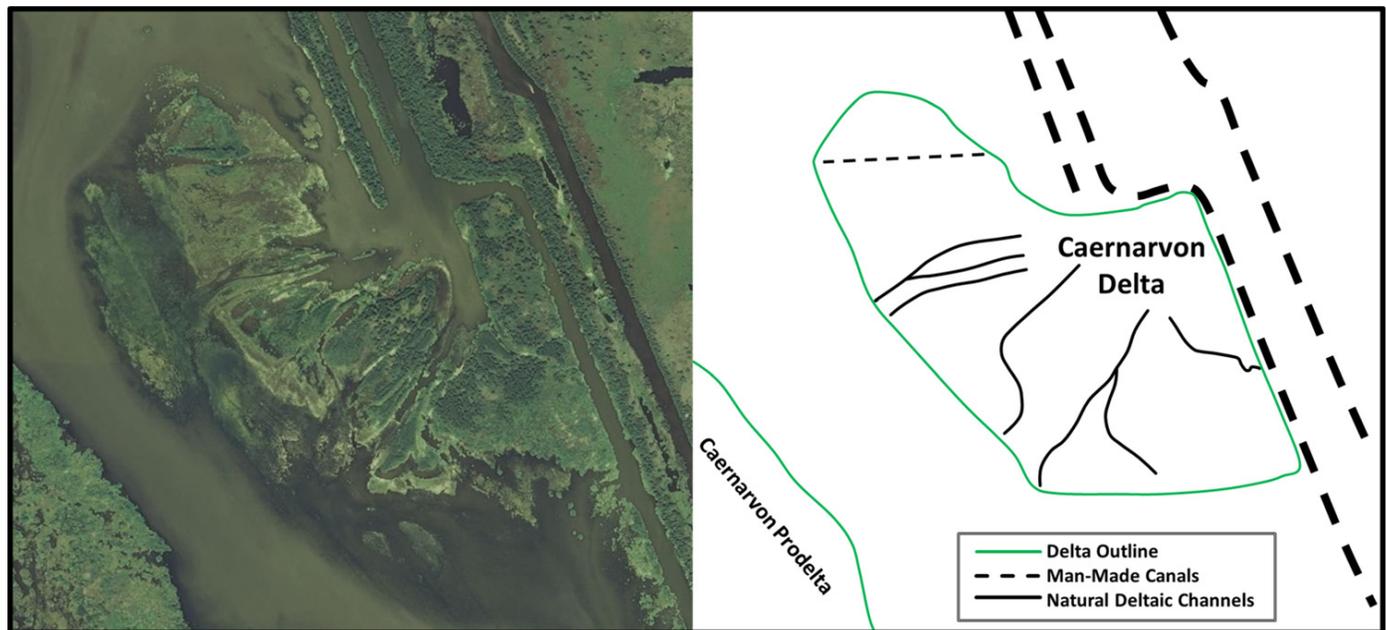
Figure 6. Aerial photo from 2011 illustrating man-made canals and natural distributary channels that carry discharge from the Caernarvon Freshwater Diversion through Big Mar Pond.

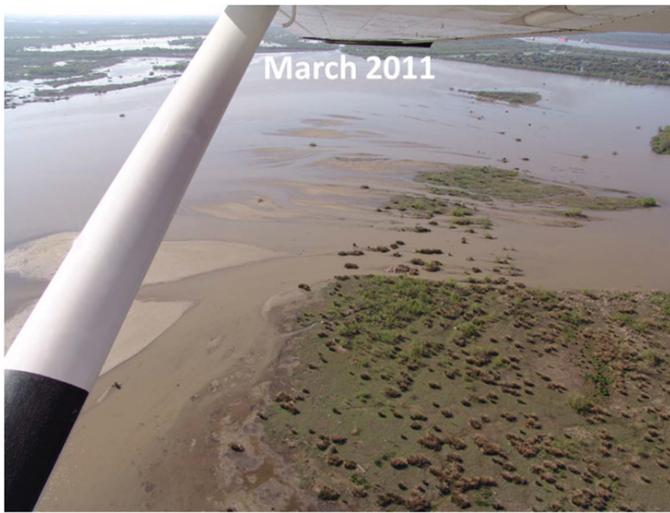
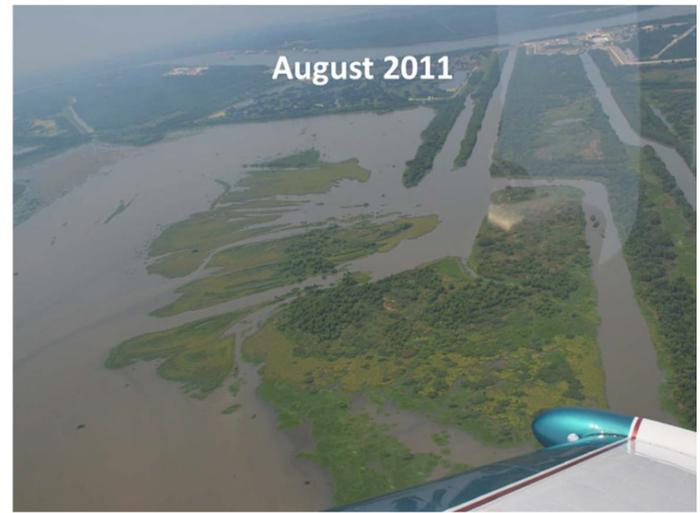
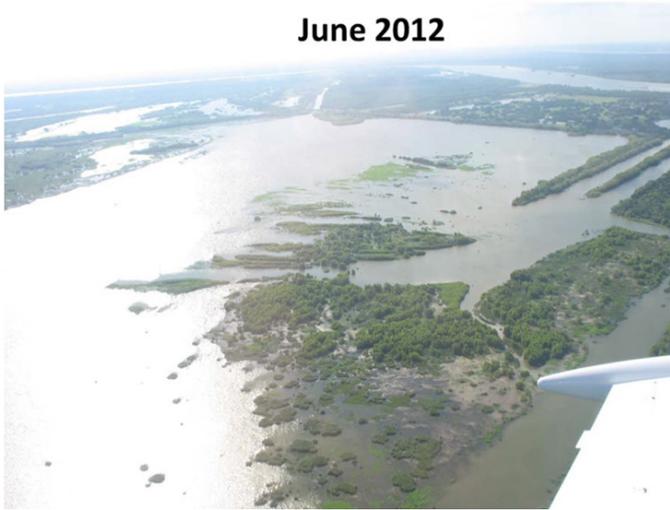
**Figure 8. Oblique aerial photographs of the Caernarvon Delta. Note expanded vegetation on bars and growth of the wetland forest.**

exposed mudflats with little vegetative cover, which represented expansion from 2010. By August of 2011, there had been more delta growth and the formerly exposed mud flat was almost 100% vegetated. The growth of the vegetated delta from 2010 to 2011 is estimated to be approximately 104 ac, which is significant growth in one growing season (Fig. 8). The delta growth and vegetation establishment and expansion on newly exposed mudflat continued through 2013 (the end of this study) (Fig. 8).

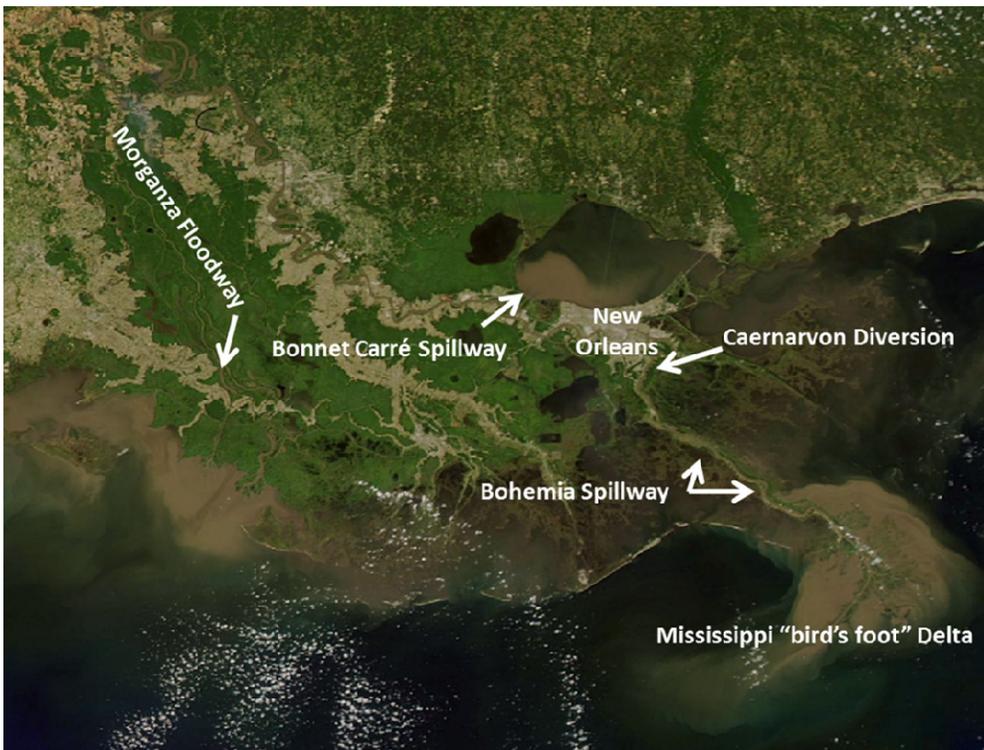
Figure 9. Location of the Bohemia Spillway in relation to New Orleans and other river outlets. Also shown is Moderate Resolution Imaging Spectroradiometer (MODIS) satellite imagery obtained on May 16, 2011, during the 2011 Mississippi high water, with discharge plumes of the Mississippi River. The plumes initiate from various engineered and non-engineered outlets from the river, and they trace how high freshwater and sediment is currently distributed into coastal environments during high water events.
